Structural Retrofit of Special Moment-Resisting Frames of Concrete

A case study

BY RAYMOND A. BUGH, SCOTT FISCHER, AND S.K. GHOSH

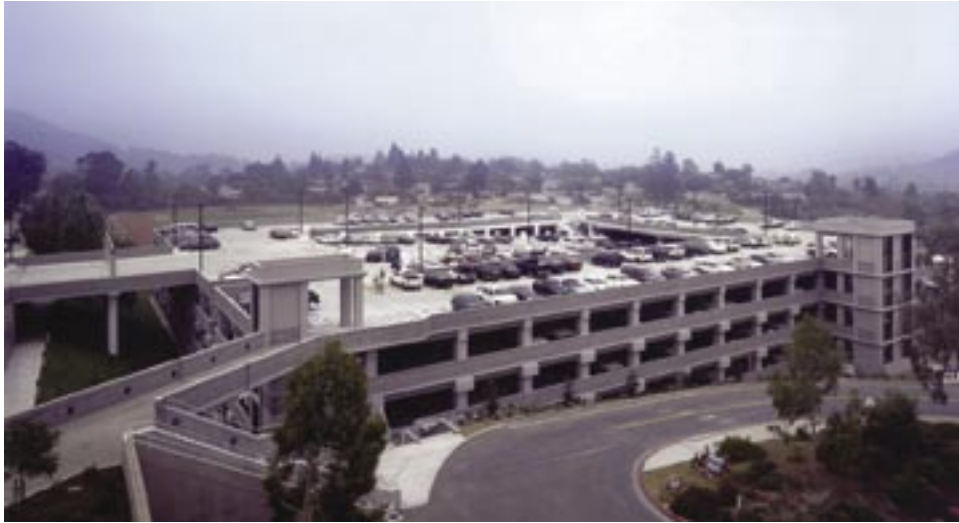
Fig. 2: View of the completed parking structure with reinforced joints at the lower two levels

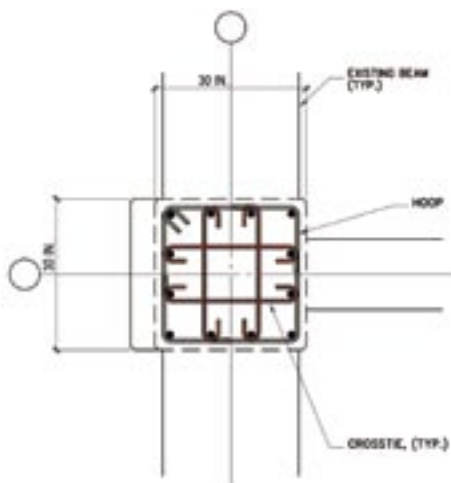
Moment frame joints must have transverse confinement reinforcement to strengthen the concrete within the joints and to provide lateral support for the vertical column reinforcement. This confinement steel is normally comprised of hoops and cross-ties (Fig. 3). Both are considered critical for adequate performance of joints as well as overall structural stability and are therefore required by code.²

Each moment frame joint was designed to include 36 cross-ties. During the course of construction, it was discovered that, although column hoops had been installed in the joints, the required cross-ties had not. The installed joint reinforcement was therefore half of that required by code.

Fig. 3: As-designed joint reinforcing

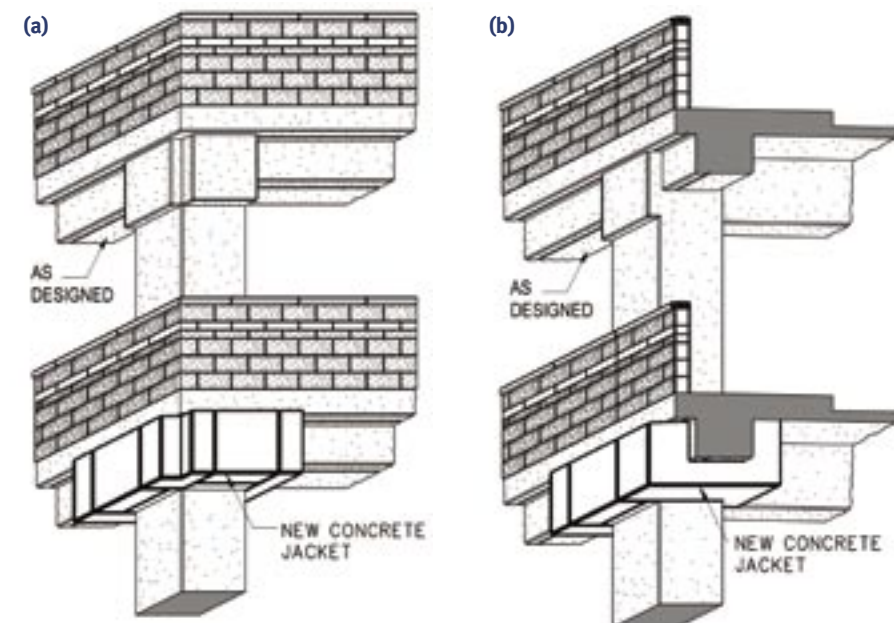
Fig. 5: Isometric studies of as-designed and repaired joints: (a) corner; and (b) interior

Once the concrete option was selected, the project architects were engaged to make the concrete jackets look as pleasing as possible. The jackets were sized and shaped to match the existing architecture of the structure, and reveals were suggested to add visual interest. Figure 5 shows the proposed repair as designed by the architect, and Figure 6 shows the finished repair.

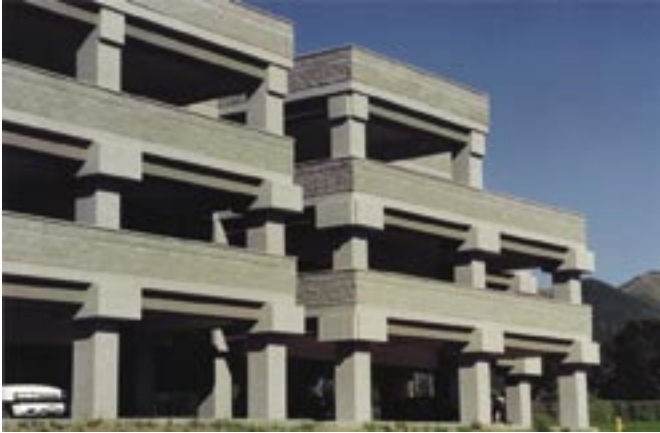
Fig. 6: Ground-level view of completed structure

The completed retrofit integrates well with the original architectural design, and is not noticeable to an untrained eye. The concrete jackets provide an economical, durable, and low-maintenance solution that fully restores the seismic performance of the structure. Though nobody wins in a situation like this, there is satisfaction gained from knowing that the project was properly repaired, and that the pleasing look of the finished repair satisfied the client.

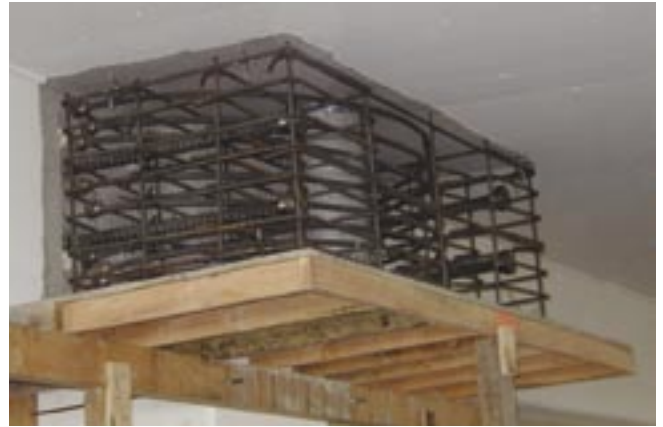
Fig. 7: Reinforcing and soffit form at interior column

The jackets were reinforced with a series of tightly spaced circular ties, through-bars, crossties, and small column cages designed to anchor and confine the circular ties (Fig. 7). All reinforcement was low-alloy, ASTM A 706, Grade 60.³ The circular ties were provided to confine the sides of the columns. They were proportioned to satisfy UBC Section 1910.9.3 (Eq. 10-6) for spiral reinforcement and UBC Section 1921.4.4.1 (Eq. 21-2) for confinement.

Given that the cross-sectional dimensions of the jackets ranged from 48 to 60 in. (1015 to 1525 mm) wide, the circular reinforcement typically comprised No. 6 bars spaced at 3.5 in. (89 mm) on center. Where beams interrupted the arc of the circular reinforcement, headed anchors were provided.

Through-bars were provided to confine the face of the beams framing into the joint. These bars had to replace the area of steel lost by the missing crossties and match the area of steel of five No. 6 circular ties. To achieve both goals, No. 14 bars with threaded terminating anchors were selected. The through-bars were designed to overlap with, and to restore the continuity of, the circular ties where they were interrupted by beams. Small column cages located in the corners of the jackets provided a core of confined concrete to anchor the terminating anchors on the No. 6 and No. 14 bars. They also provided an internal, reinforced spreader beam to distribute the clamping force from the through-bars to the face of the intersecting beams.
