Structural Retrofit of Special Moment-Resisting Frames of Concrete

A case study

BY RAYMOND A. BUGH, SCOTT FISCHER, AND S.K. GHOSH

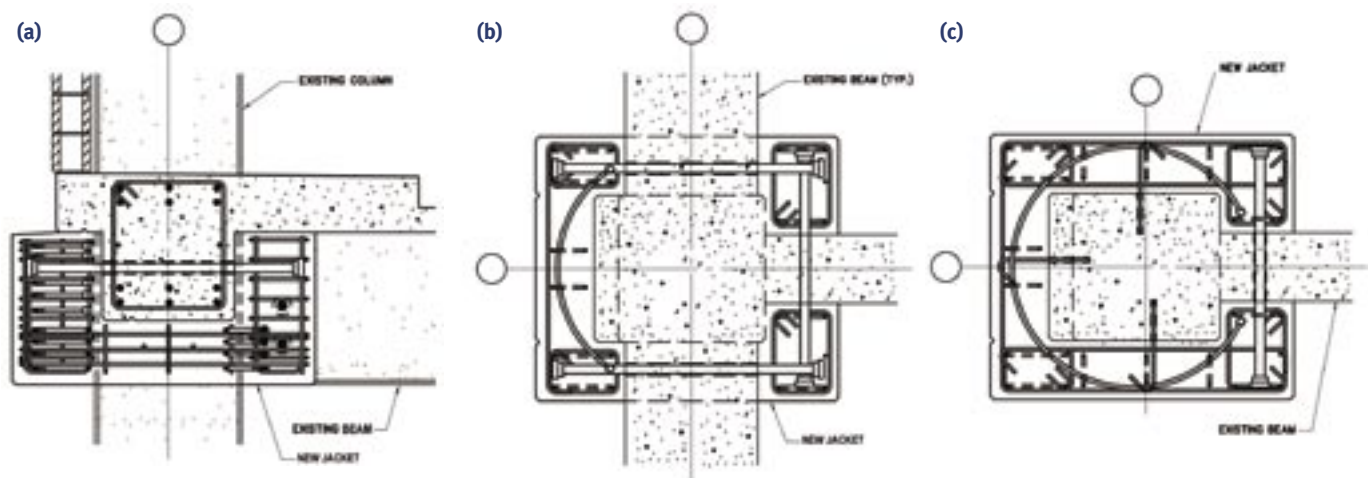
Fig. 4: beam soffit

The discovery that the cross-ties were not in the joints of the second and third levels was made during the construction of the fourth level. Once detected, the problem was quickly corrected at the fourth level by installing cross-ties in the joints prior to placing concrete. External strengthening was required at the 240 joints that had already been cast at the second and third levels. The typical column size was 30 in. (760 mm) square with a 12-bar configuration. Most of the frame joints had beams on three sides (Fig. 4). The intersecting beams obstructed opportunities to wrap the joints cleanly and added to the complexity of the repair. Also, post-tensioning cables passed through some joints, adding risk to any drilling during the retrofit operations.
